October 23, 1978

Re: Ground Water Quality

Systech Waste Treatment Center

Franklin, Ohio

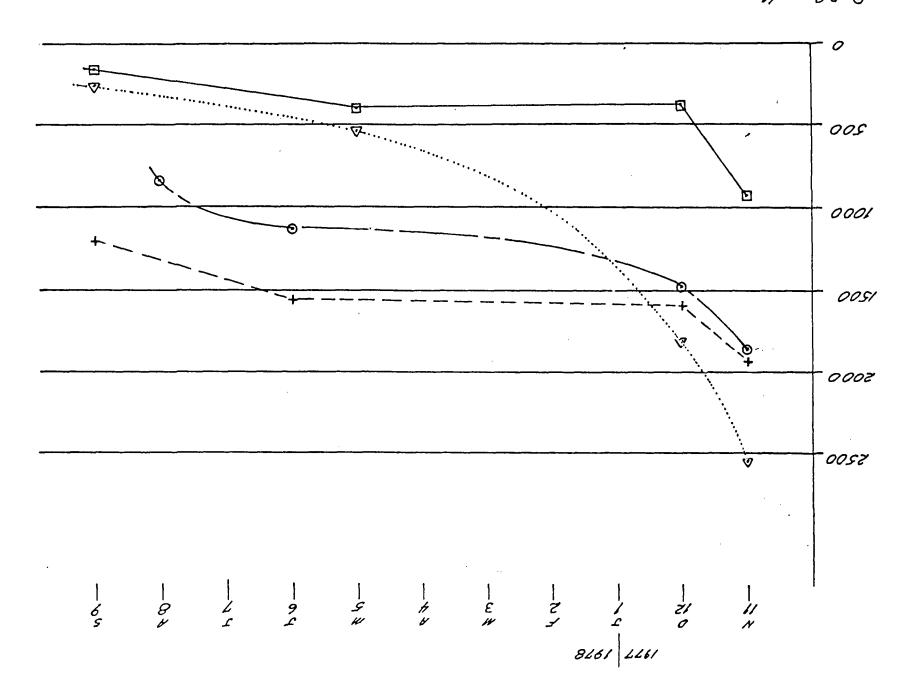
## SYSTECH MASTE TARAMENT CENTERS SYSTECH MASTE TARAMENT CENTERR

To remove the contaminated ground water from the vicinity of monitoring Well No. 139 it is my understanding that a 3 H.P. centrifugal pump has been operating intermittently for the past several months. It is interesting to note the trend in ground water quality during this time. Several of the included parameters have been plotted and are included herewith. The marked reduction in these parameters suggest the effectiveness of the purging operation of Well No. 139. This marked decrease in the concentration of the contaminants together with a pumping rate of only 30 g.p.m. could suggest a

rather limited extent of ground water contamination. This is also reinforced by the absence of any contaminating parameter within Monitoring Well No. 133.

0-03 mg/l. -7.0.C. mg/l. D-0.0.D mg./l. X-0.00000011111
